Questions 'N' Answers

From Cornell Local Roads Program - April 1990

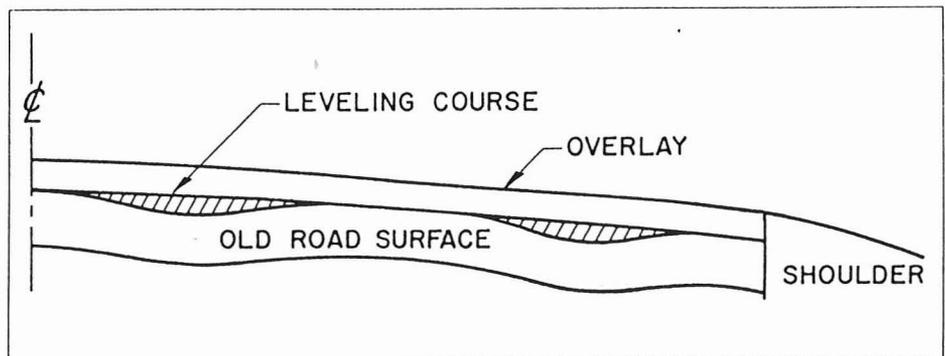
Figure 1. Overlay of uniform thickness on top of leveling course

The leveling course helps to eliminate the return of the wheel path ruts. An overlay that is placed above the leveling course will be of uniform thickness across the lane (Figure 1). When it is compacted (typically by a steel drum roller) the density is uniform. If good density is achieved, traffic will not have much effect on it. If the leveling course is omitted, then when the overlay is placed it is thicker in the wheelpaths by the amount of the rut depth (Figure 2). When the overlay is compacted, the material between the wheelpaths gets more compaction effort because it is thinner than the material in the wheelpaths. Traffic gradually compacts the material in the wheelpaths, and the ruts reappear.

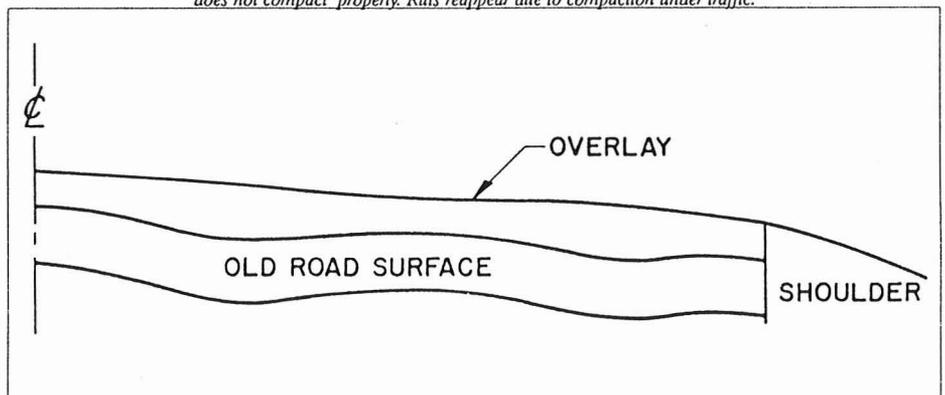
Overlay of non-uniform thickness on top of the old road surface. Material in the wheelpaths does not compact properly. Ruts reappear due to compaction under traffic. ■

Figure 2. Overlay of non-uniform thickness on top of old road surface. Material in the wheelpaths does not compact properly. Ruts reappear due to compaction under traffic.
