ROAD BUSINESS

On the Road in New Hampshire *Two Slip Lining Culvert Projects*

Winter 2006

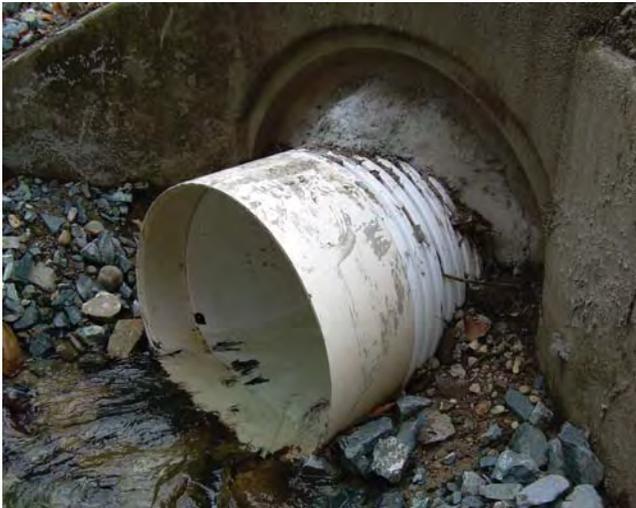
The outlet end of the newly installed slip lining in Plymouth on Fair Grounds Road

The picture on this page shows the completed installation of a liner. The existing culvert was 25' deep and 100' long. The 48" cement culvert was lined with a 36" liner. A 36" liner was used because the cement culvert was no longer straight and could not accommodate a larger liner.

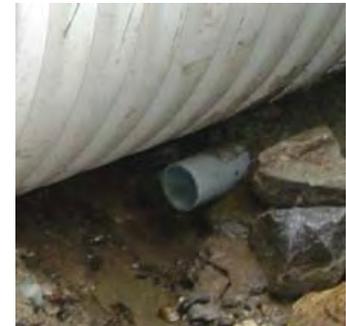
Right: PVC weep hole pipe. The pipe will be capped before grouting begins.

Beneath the liner, they placed another two-inch PVC pipe as a weep hole (to allow water to exit between the culvert and liner). The weep hole was capped before grouted. It is vital to dewater the culvert and liner to allow the grout to set-up and cure.

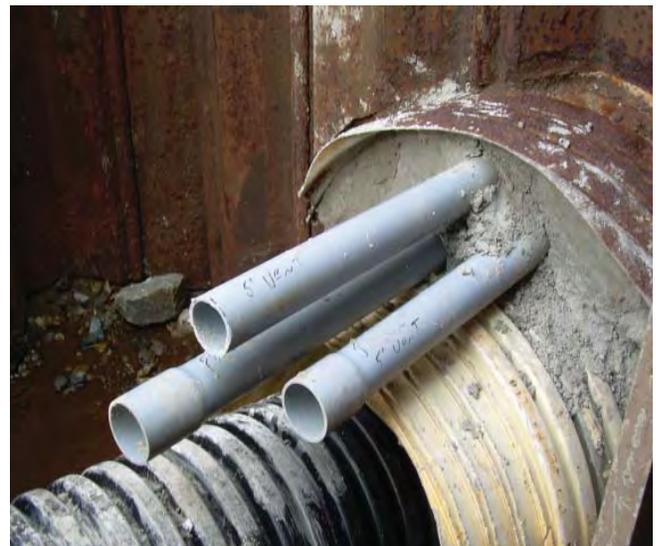
Below: An installation of Rt 25, after grouting at the inlet end, 2 PVC vent pipes on top of the PVC pipe used to deliver the grout.

These projects used a 8-12 bag mix (eight bags of cement to one yard of concrete sand) cement grout. Once mixed, it was screened so it didn't clog the PVC pipe that delivered the material. If the PVC pipe became clogged then one of the two vent pipes can be used.

They maintained a pump pressure of less than five psi. They closely watched the pressure as it can increase rapidly. They begun pumping at the half-way point of the space (from the inlet end). It took about a half-day to grout and it cured within a few hours. The biggest challenge was in estimating the quantity of grout needed, as any cracks or holes in the old culvert, may allow the grout to leach into existing soil or cracks in the liner may occur.
